SERVICE NEWS

VOLUME 25

MARCH, 1953

NUMBER 3

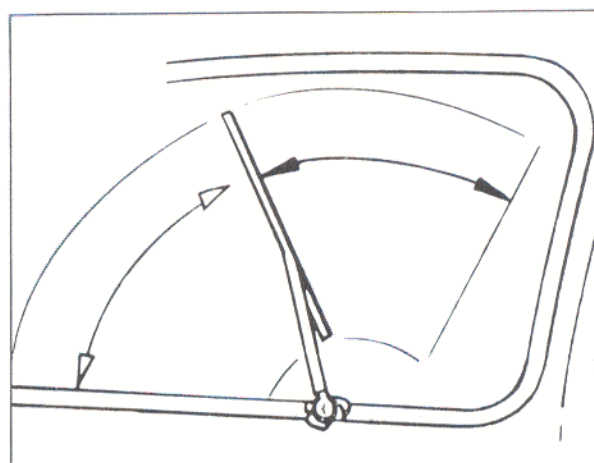
Fig. 1

Correct windshield wiper cable tension is important for efficient operation of the windshield wiper mechanism. Tight cables cause slow wiper operation and possible stall at the center of travel on wet windshields. Loose cables result in blade slap and over travel at the end of stroke. Wipers should operate on a wet windshield with vacuum of 4 lbs. minimum.

1. On early production models having an auxiliary drive lever on the motor, move the wiper arms by hand up into the center of the arc, midway between the two extremities of travel (fig. 1). With the arms in this position, the motor auxiliary drive lever should be in a vertical position and should remain in vertical position during all steps of adjustment procedure.
2. Vehicles produced after approximately February 2, 1953 will have a spiral drive in place of the auxiliary drive lever on the motor and will not require positioning of the blades to perform the following adjustment.
3. Remove one wiper arm and blade without altering the position of the transmission shaft.
4. Loosen the screw in the end of the transmission shaft approximately $\frac{3}{4}$ turn (fig. 2). Tap

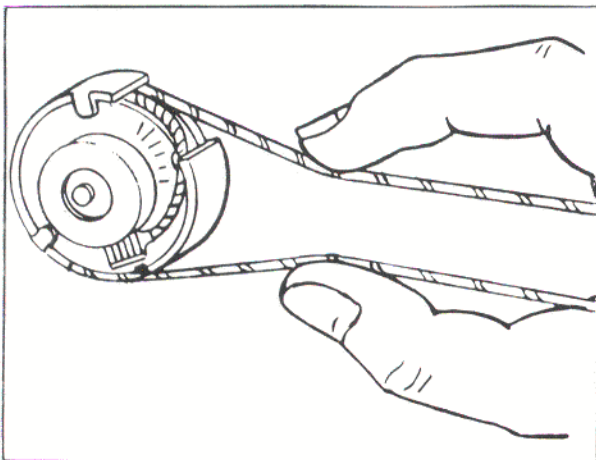
Fig. 3

5. Reach up under cowl and take the cables between the thumb and forefinger and increase finger pressure until one notch movement of the transmission serrations can be felt and/or heard (fig. 3). While holding the cables in this position, retighten the tension screw in end of transmission shaft (this step is a two man operation).

NOTE: Serration contact is lost if tension screw is loosened excessively.

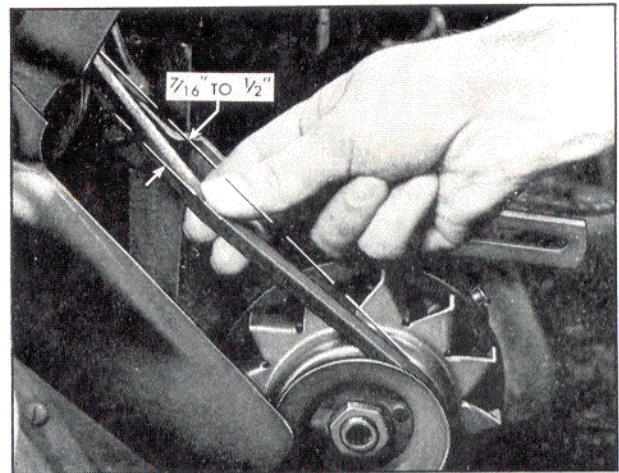
Fig. 4

In order to obtain durability and quietness with the new narrow fan belts used in 1953 on passenger cars, $\frac{1}{2}$, $\frac{3}{4}$ and 1 ton truck models, it is very important that the belt have adequate tension. The narrow belt is much more critical with regards to tension than was the wide belt used on all models in 1952 and on the $1\frac{1}{2}$ and 2 ton truck models in 1953.

The narrow fan belt should be adjusted to provide $\frac{7}{16}$ "- $\frac{1}{2}$ " deflection at a point midway between

fan and generator pulleys (fig. 4). Proper adjustment for the wide fan belt remains at $\frac{3}{4}$ " deflection.

To insure that the narrow fan belts have sufficient tension after their initial stretch, the tension of the belt should be checked at the 1000 mile inspection. If the belt deflects more than $\frac{1}{2}$ " resisting approximately a 15 lb. load midway between the generator and fan pulleys, it should be retensioned.

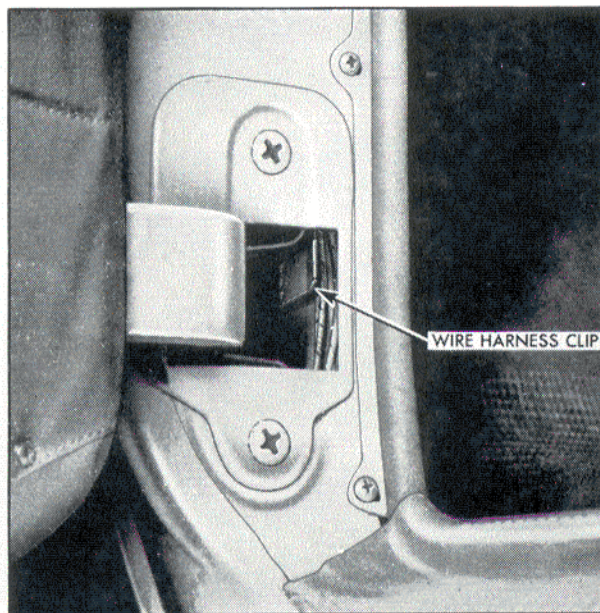
Fig. 5

As a precautionary measure on 1953 Chevrolet Convertible, check the left door lower hinge box

(fig. 5) to make sure that the body wire harness is placed behind the wire harness clip attached to the right side of the hinge box. In the event there is not enough slack in the harness to perform this operation, remove the left cowl kick pad to gain access to the other harness clips.

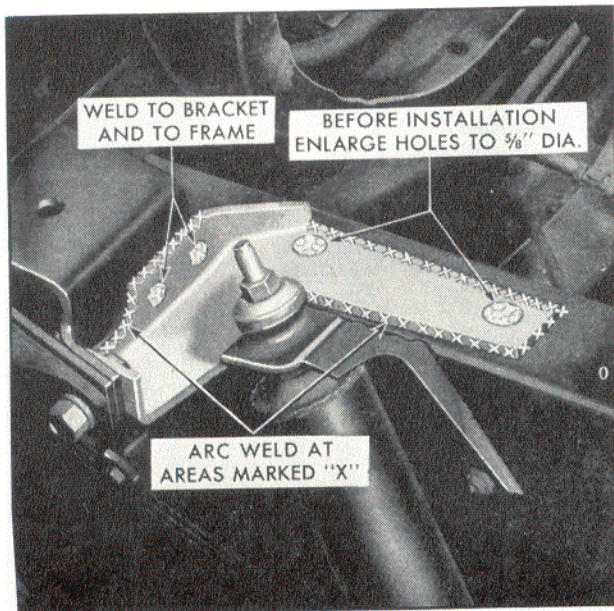
Fig. 6

A steering gear bracket reinforcement which increases the stability of the steering gear bracket on Forward Control Models is now in production and may be obtained from parts stock for installation on earlier models.

1. Remove necessary body parts to make area at rear of the steering gear housing and frame in that vicinity accessible for the reinforcement installation.
2. Enlarge the two holes in section of reinforcement which mounts on the frame to approximately $\frac{5}{8}$ " diameter so that the frame rivets will enter holes allowing reinforcement to set flat against frame.
3. Bolt reinforcement to steering gear housing and bracket using a $\frac{7}{16}$ -20 x $1\frac{1}{2}$ " hex head bolt. Clamp reinforcement to frame and weld to frame and bracket as shown in Figure 6.
