SERVICE NEWS

VOLUME 25

AUGUST, 1953

FRONT AND REAR DOOR LOCK INTERFERENCE

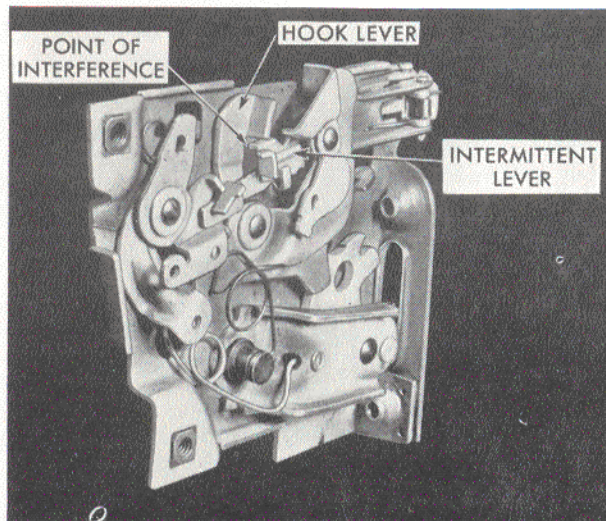
Fig. 1

In cases where the door can be opened to the "safety" position, with the locking rod in the locked position, by actuating the outside push button it is indicative of interference between the door lock intermittent lever and the hook lever. Correction may be made in the following manner:

3. Check the accessibility of the door lock intermittent lever (fig. 1) through the opening between the door inner and outer panels.
4. Using a screwdriver or some other suitable tool (fig. 2), carefully bend the intermittent lever inboard to gain operating clearance for the lever. A few thousandths adjustment is sufficient to obtain this clearance.

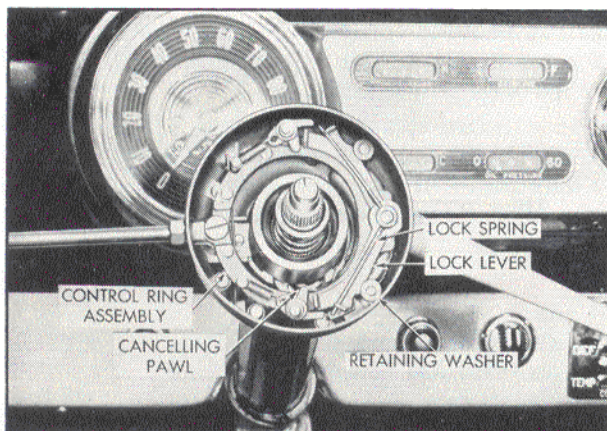
Fig. 3

In reviewing complaints on inoperative direction signals it has been found that the lock levers on some direction signals have jumped over the retaining washers (fig. 3) causing the direction

signal to become inoperative. Investigation has shown that this malfunction is caused when the direction signal control lever is held in the engaged position while making a turn. It may also result when the directional signal control lever is

moved into engagement during a turn. Excessive clearance at the pivot screw also contributes to the possibility of the failure. Design changes have been made at these points to correct this complaint. Field correction of this problem where it exists may be accomplished as follows:
